# Manhole Inspection Summary

Manhole # S37S\_\_031MH

Insp Date: 2/20/08 1:58 PM

**Location** Address: **1411 Covington**

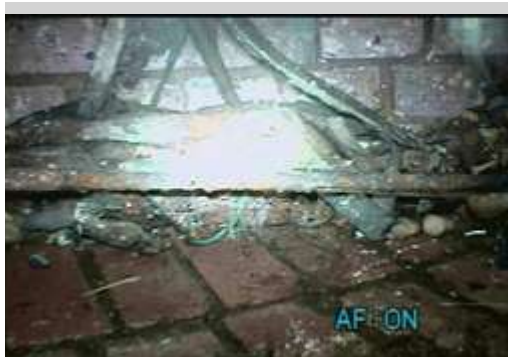
misc

Bench DEBRIS

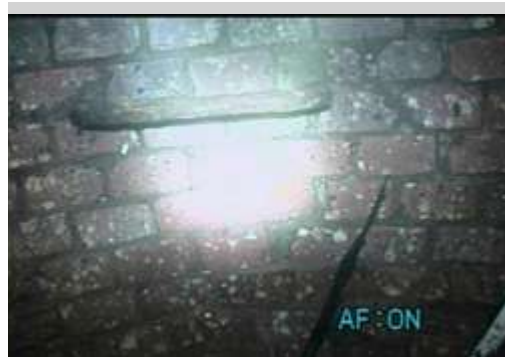
Defect 2

**Steps** Count: **8** Missing: **0** ☒ **Corroded**

corroded steps

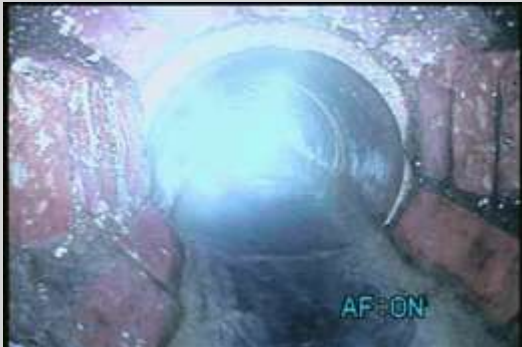
12 O'Clock Outflow

10 in. Circular Gravity Sewer  
Pipe Out @ 12 O'Clock

Invert Depth: **12.70** (ft.) Flow Characteristics: **Fast**

Deposits: ☒ None ☐ Mud ☐ Sludge ☐ Debris ☐ Grease

Infiltration: **None** Pipe Seal Cond: **Unknown**

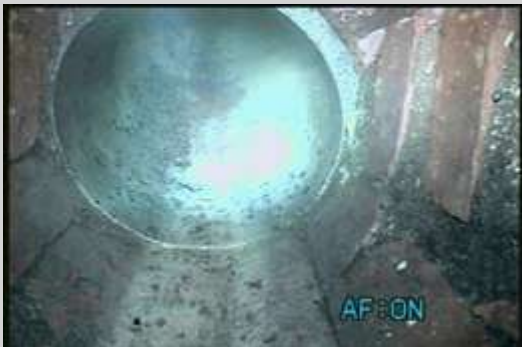
3 O'Clock Inflow

8 in. Circular Gravity Sewer  
Pipe In @ 3 O'Clock

Invert Depth: **12.50** (ft.) Flow Characteristics: **Slow**

Deposits: ☒ None ☐ Mud ☐ Sludge ☐ Debris ☐ Grease

Infiltration: **None** Pipe Seal Cond: **Unknown**

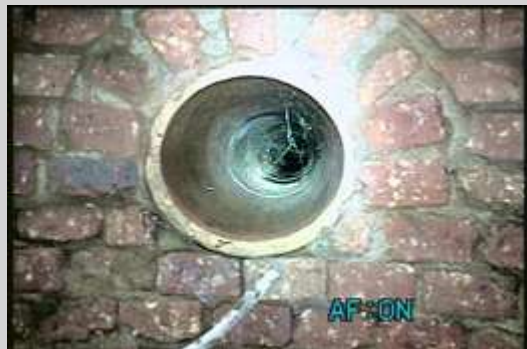
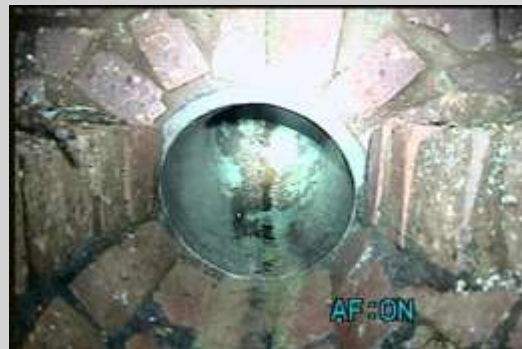
9 O'Clock Inflow

8 in. Circular Gravity Sewer

Pipe In @ 9 OClock

Drop In @ 9 OClock

Invert Depth: **12.60** (ft.) Flow Characteristics: **None**

Infiltration: **None** Pipe Seal Cond: **Unknown**
